WUDPAC PAINTINGS BLOCK
EXAMINATION REPORT AND TREATMENT PROPOSAL

ACCESSION #	2024.0019A,B
ARTIST	Hans Heinrich "Henry" Bebie
TITLE	<i>Portrait of a Woman</i>
DATE	c. 1850-1860
MEDIUM	Oil on canvas
SIZE	H 68.1cm x W 55.1 cm (H 26.75 in x W 21.75 in)
EXAMINED BY	Elizabeth Glander
DATE	March 19, 2025
CONSULTANTS	Bianca Garcia, Associate Conservator of Paintings and Programs Manager at Balboa Art Conservation Center Mina Porell, Associate Paintings Conservator at Winterthur Museum, Garden and Library

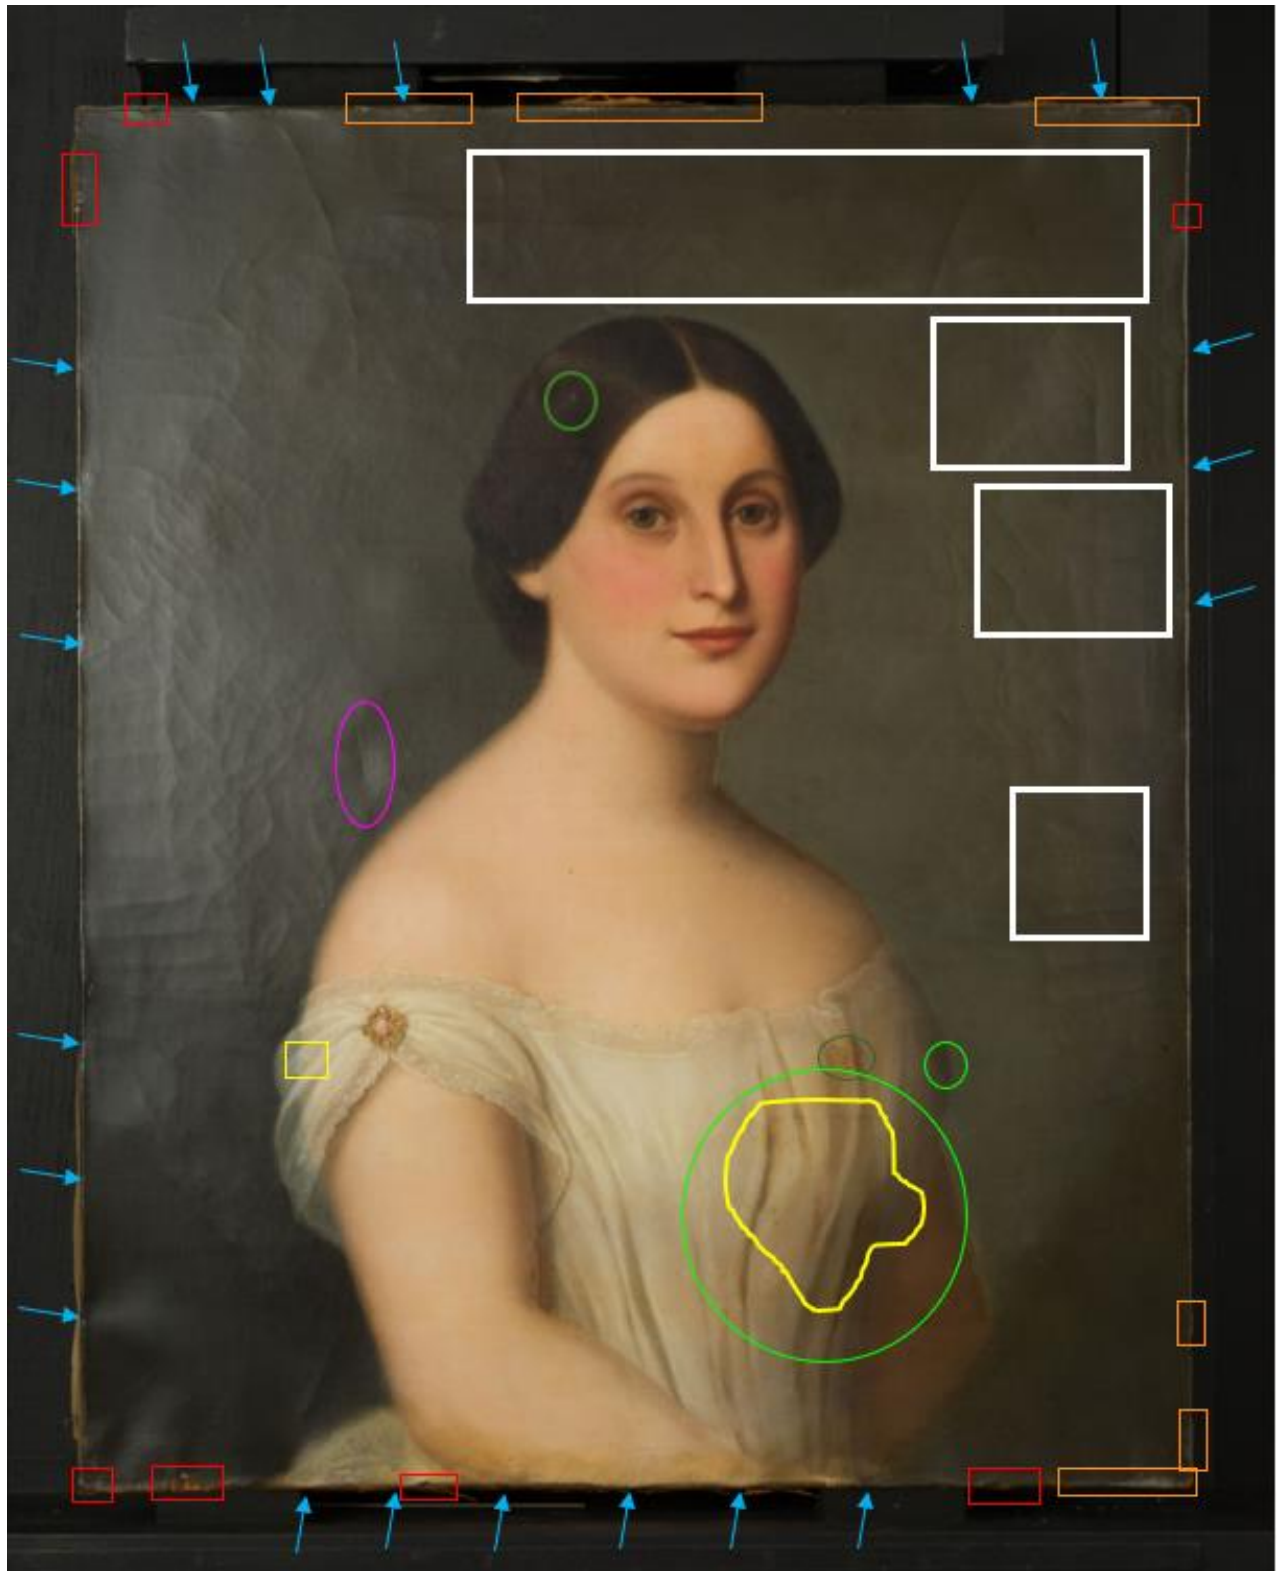
Figure 1a. Condition map of the painting, recto.

Red = Area of loss Orange = Abrasion Yellow = Tear Light Green = Inpainting/over painting
Dark Green = Insert and over paint Light Blue = Cusping Pink = Impact damage
White = Possible inclusions in the paint layer that are small and rounded

There is impact damage above the sitter’s left shoulder, a small circular puncture that has been filled in the hair, an L-shaped tear in the outer sleeve of the sitter’s left arm, and a compound tear in the torso, which are visible in the x-ray radiograph (fig. 3a-d). Table 2 below lists the size, location, and notes about each of these damages.

The paint layer is in good condition. There are stress cracks throughout the entire painting, however, there is no lifting or flaking paint. These stress cracks likely result from mechanical stress due to fluctuating environmental conditions because where the frame covered the painting, there are less cracks compared to where the rest of the painting has been

uncovered. There is some discolored inpainting and overpaint that corresponds to tears and areas of loss mentioned above and are visible in the x-radiograph (fig. 10) and in UV illumination (fig. 12).

4. Stabilize lifting paint around the L-shaped tear, the complex tear, and the loss with a water-soluble adhesive.
5. Mend the L-shaped tear and the complex tear with a water-soluble adhesive using the single-thread bonding technique.

6. Fill any sizeable losses in the support by attaching new canvas inserts or new threads with water-soluble adhesive.
7. Apply an edge lining to the lower tacking edge.

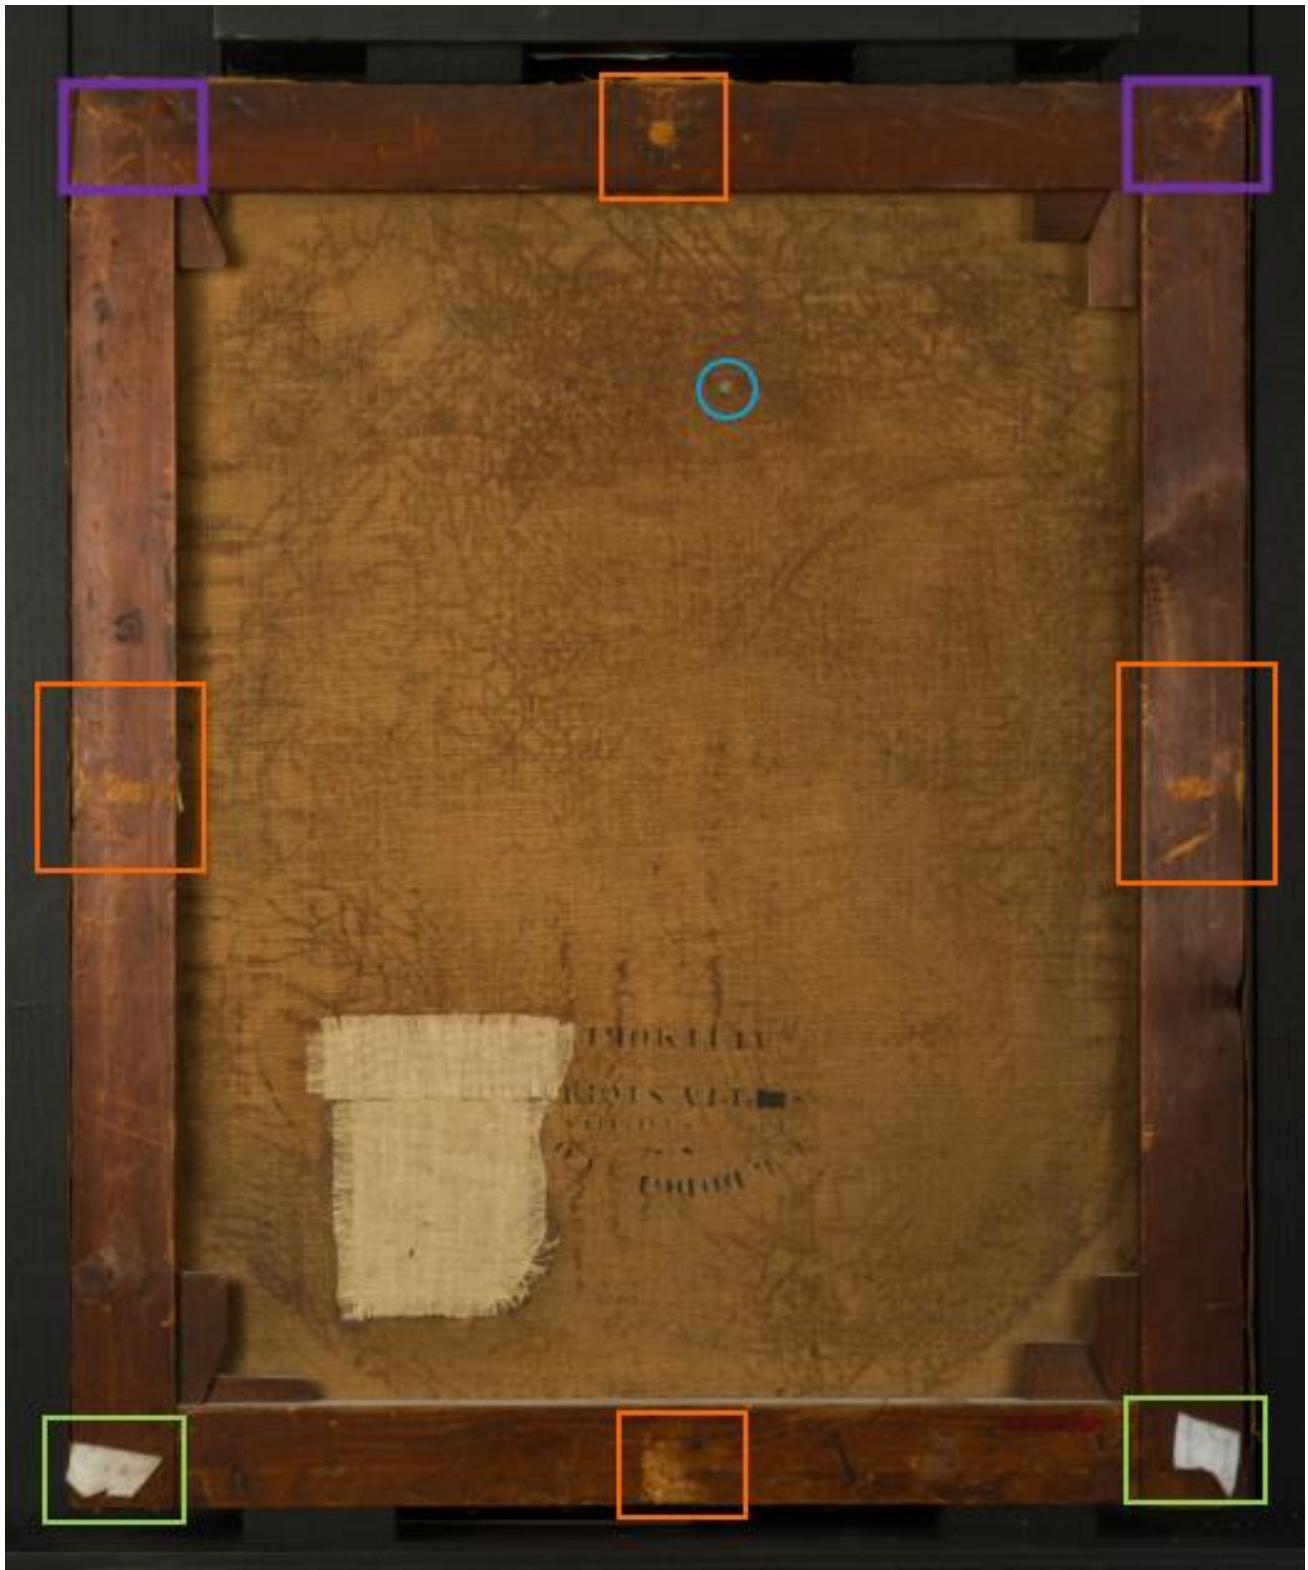
Figure 1b. Condition map of the painting, verso.

Orange = Abrasion **Light Blue** = Fill
Light Green = Felt adhered to stretcher **Purple** = Adhesive and felt residue from being removed

Overall, the stretcher is stable and in good condition. There are abrasion marks at the center of each stretcher member, likely from nails and tools used to fit the painting into the frame multiple times. The lower two corners have irregularly cut pieces of white felted fabric adhered to the stretcher. There is some adhesive residue on the upper two corners, possibly from more felted fabric that is no longer attached. The lower right two keys are loose while the other six keys are secure. One of the keys in the upper left corner is much smaller than the rest. There is a thick layer of dust on the lower member of the stretcher as well as the four lower keys.

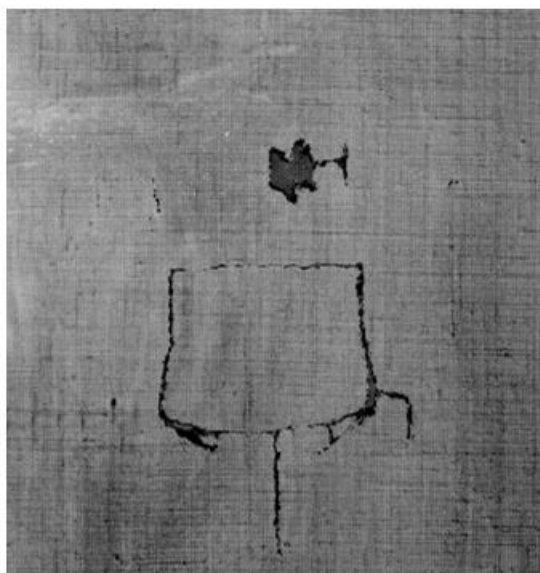
Figure 3a. Detail of the x-ray radiograph showing the complex tear and canvas insert with a different ground. The weave structure of the patch can be clearly seen in the top area of loss. [Pantak-Seifert Eresco 65 MF2](#) with digital control. [CRxVision Versatile Computed Radiography \(CR\)](#) tabletop Scanner with IPS Phosphor Imaging Plates. Scans collected with GE Rhythm RT software and processed with GE Rhythm Review software. X-radiograph taken at 25kV, 5mA, 30sec.

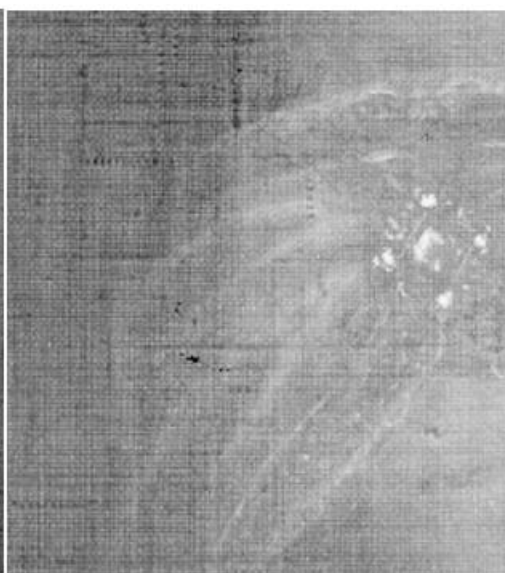
Figure 3b. Detail of the x-ray radiograph showing the L-shaped tear. This shows that the tear has not fully broken the fibers of the canvas. [Pantak-Seifert Eresco 65 MF2](#) with digital control. [CRxVision Versatile Computed Radiography \(CR\)](#) tabletop Scanner with IPS Phosphor Imaging Plates. Scans collected with GE Rhythm RT software and processed with GE Rhythm Review software. X-radiograph taken at 25kV, 5mA, 30sec.

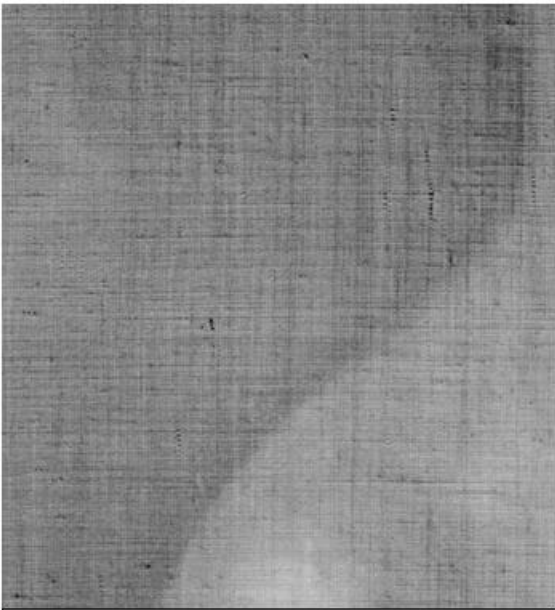
Figure 3c. Detail of the x-ray radiograph of the impact damage. [Pantak-Seifert Eresco](#) 65 MF2 with digital control. [CRxVision](#) Versatile Computed Radiography (CR) tabletop Scanner with IPS Phosphor Imaging Plates. Scans collected with GE Rhythm RT software and processed with GE Rhythm Review software. X-radiograph taken at 25kV, 5mA, 30sec.

- e. After testing the moisture-sensitivity of the canvas and mending all tears and losses in the primary support along the lower edge, local humidification will be performed from the back of the canvas to relax the planar deformations and the impact distortion.

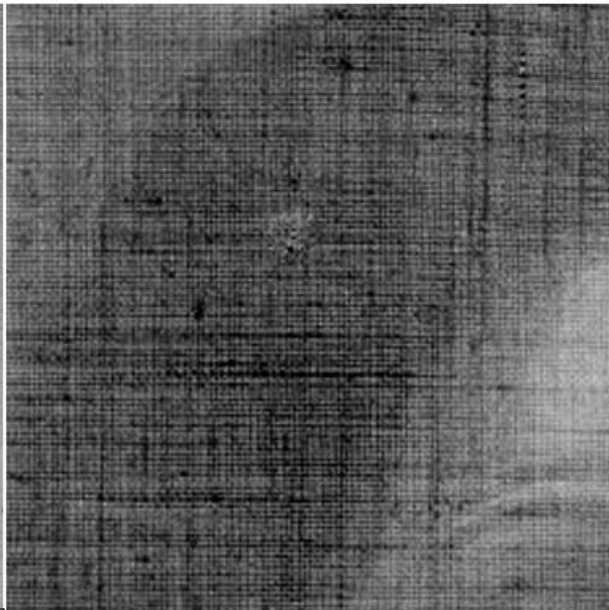
Figure 3d. Detail of the x-ray radiograph of the circular puncture. [Pantak-Seifert Eresco](#) 65 MF2 with digital control. [CRxVision](#) Versatile Computed Radiography (CR) tabletop Scanner with IPS Phosphor Imaging Plates. Scans collected with GE Rhythm RT software and processed with GE Rhythm Review software. X-radiograph taken at 25kV, 5mA, 30sec.

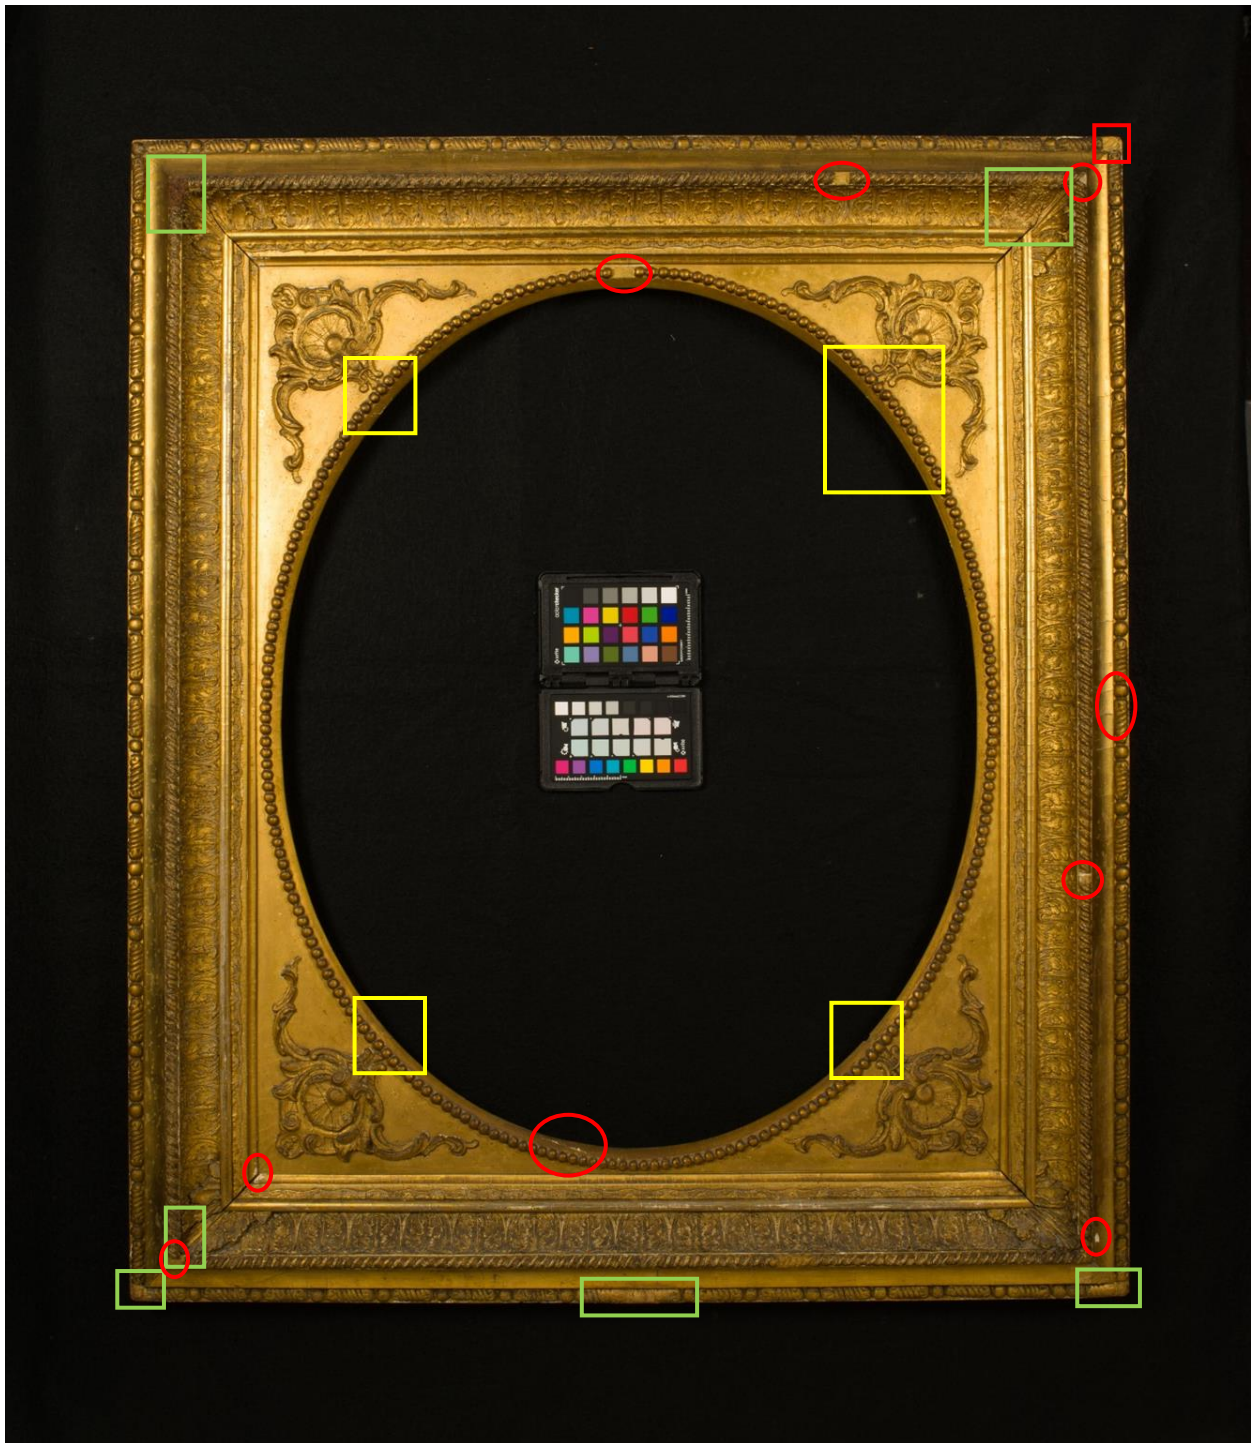
Figure 6a. Condition map of the frame, recto.

The recto is covered in a light layer of dust and surface grime. There are multiple losses in the composition ornament and areas that have been filled and inpainted. See table 3 below for location and size.

Description	Location	Size (H x W)	Notes
Loss of two beads running pattern	Upper center of oval sight line ~ 13 cm from upper edge ~37.5 cm from right edge	1 cm x 1.7 cm	Inpainted with gold paint.
Loss of rope twist running pattern	Near upper right corner ~5 cm from upper edge ~22.5 cm from right edge	1.1 cm x 1.3 cm	Inpainted with gold paint.
Fill just in carved detail below rope running pattern	In upper right corner ~6.5 cm from upper edge ~8.5 cm from right edge	4 cm x 3 cm	Inpainted with gold paint.
Loss of rope twist running pattern	In upper right corner ~5 cm from upper edge ~5.5 cm from right edge	1 cm x 0.7 cm	White composition exposed.
Loss in running pattern in upper right corner	In outermost upper right corner	1.4 cm x 1.6 cm	Inpainted with gold paint.
Loss in highly burnished area and loose compo	Center of right vertical edge 22.5 cm from upper edge 1.3 cm from right edge	1.8 cm x 0.3 cm	Bare wood exposed.

Loss of rope twist running pattern	Just below center on right vertical edge ~33.5 cm from lower edge ~5.3 cm from right edge	1 cm x 1 cm	Composition exposed.
Loss of highly burnished area	Just above lower right corner ~5 cm from lower edge ~2.8 cm from right edge	0.6 cm x 0.7 cm	Bare wood and compo exposed.
Fill of rope running pattern	Lower right corner ~5 cm from lower edge ~5 cm from right edge	1 cm x 1.1 cm	Inpainted with gold paint.
Fill of lower right corner	Lower right corner	2.8 cm x 3.3 cm	Inpainted with gold paint.
Fill of outermost running pattern	Lower horizontal edge 0 cm from lower edge ~ 35.5 cm from left edge	1.4 cm x 5 cm	Inpainted with gold paint.
Fill of lower left corner	Lower left corner	1.2 cm x 1.8 cm	Inpainted with gold paint.
Loss of rope twist running pattern	In lower left corner ~5 cm from lower edge	1.1 cm x 1.8 cm	Inpainted with gold paint.

~5 cm from left edge		
Fill of carved detail in lower left corner	In the lower left corner ~7 cm from lower edge ~6.5 cm from left edge	1 cm x 1.1 cm	Appears to be red wooden fibers.
Loss of gilding in lower left corner	Lower left corner near applique ~12 cm from lower edge ~12.5 cm from left edge	1.1 cm x 0.9 cm	Composition exposed.
Cracks where the components are out of plane with each other	Sight edge of upper left applique ~22.5 cm from upper edge ~21 cm from left edge	2.2 cm x 1 cm	Complex crack.
Cracks where the components are out of plane with each other	Sight edge of upper right applique ~22.5 cm from upper edge ~22.3 cm from right edge	1.5 cm x 1.2 cm	Complex crack.
Crack where the components are out of plane with each other	Sight edge near the lower of upper right applique ~26.5 cm from upper edge ~18.2 cm from right edge	1.3 cm (length)	This is just a single crack.
Cracks where the components are out of plane with each other	Sight edge of lower right applique ~21.5 cm from lower edge ~21.1 cm from right edge	2.5 cm x 0.8 cm	Complex crack.

Cracks where the components are out of plane with each other	Sight edge of lower right applique ~21.5 cm from lower edge ~20.5 cm from left edge	2 cm x 1.3 cm	Complex crack.
Loss in burnished area	Left of lower center sight edge ~14.5 cm from lower edge ~33.3 cm from left edge	4.1 cm x 0.3 cm	Linear crack with areas of loss.

Red = Area of loss **Light Green** = Fill with inpainting
Yellow = Cracks where the components are out of plane with each other

1. Before, during, and after treatment photography will be conducted to document the condition of the frame and the course of treatment.
2. Remove surface grime with cotton swabs or dry cosmetic sponges lightly moistened with an appropriate solution.
3. Stabilize loose composition ornament with a conservation-grade adhesive.
4. Consolidate any flaking preparatory and gilding layers with an appropriate water-based adhesive.
5. Fill small areas of loss with gesso; fill larger losses by taking a mold of the original ornament and creating casts out of two-part epoxy putty.
6. Inpaint or in-gild areas of loss with conservation-grade materials to match the surrounding original material.
7. Line the rabbet with felt tape.
8. Install D-rings to the frame verso.
9. Fit the painting back into the frame with mending plates.

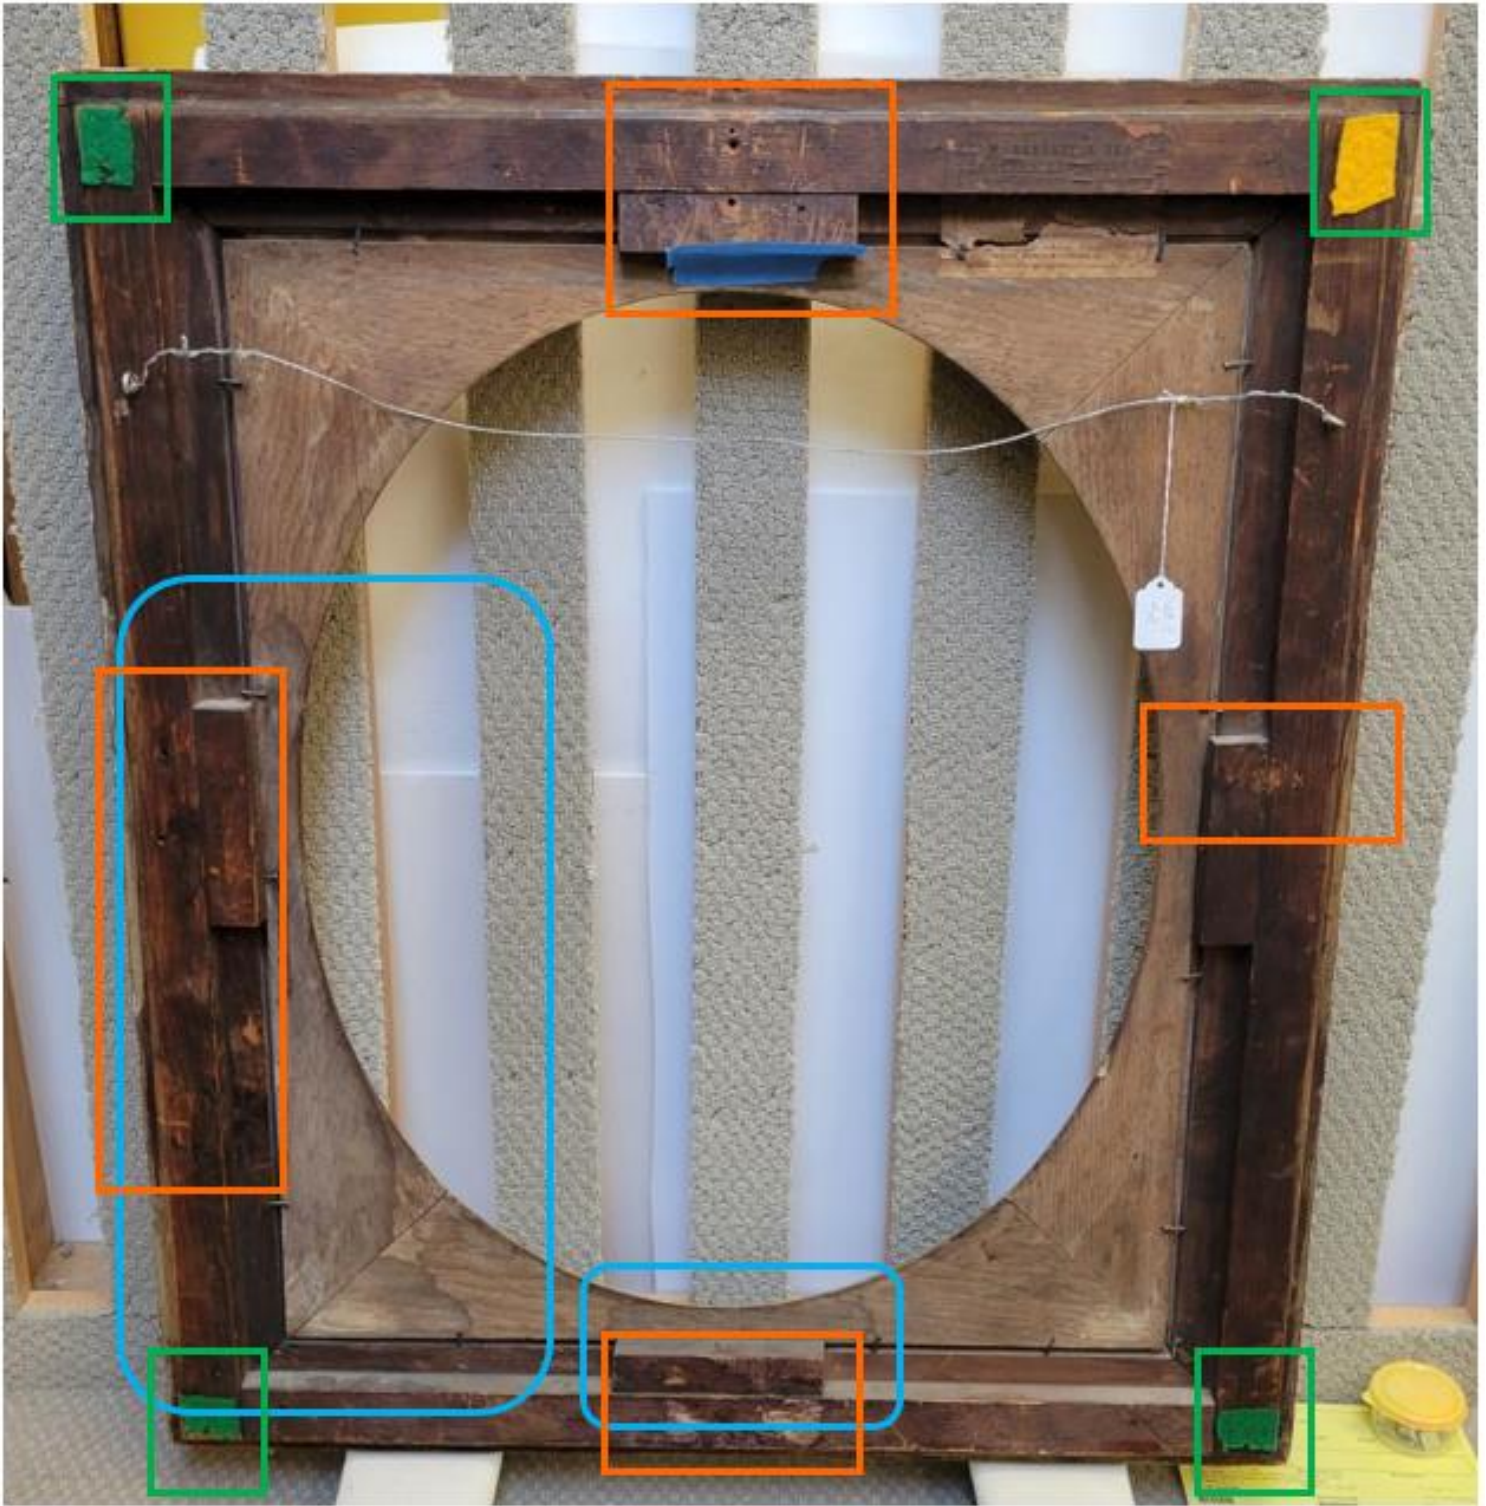
Figure 6b. Condition map of frame, verso.

The verso is also covered in dust on the horizontal surfaces. The frame rabbet does not have any padding applied to it. Each of the corners has an irregularly cut rectangle of felted fabric, possibly to help keep the frame from abrading the wall (fig. 6b).

There are abrasions located primarily in the center of each rail, most likely caused by nails being driven into the wood to secure the painting and later removed. The paper label has darkened in color and become extremely brittle. There are some losses in the paper resulting in some of the text being illegible. There are large tide lines on the left side and across the lower portion of the frame from water damage. There are no corresponding tidelines on the recto of the painting.

Orange = Abrasion

Light Blue = Water damage

Green = Felt fabric adhered to frame

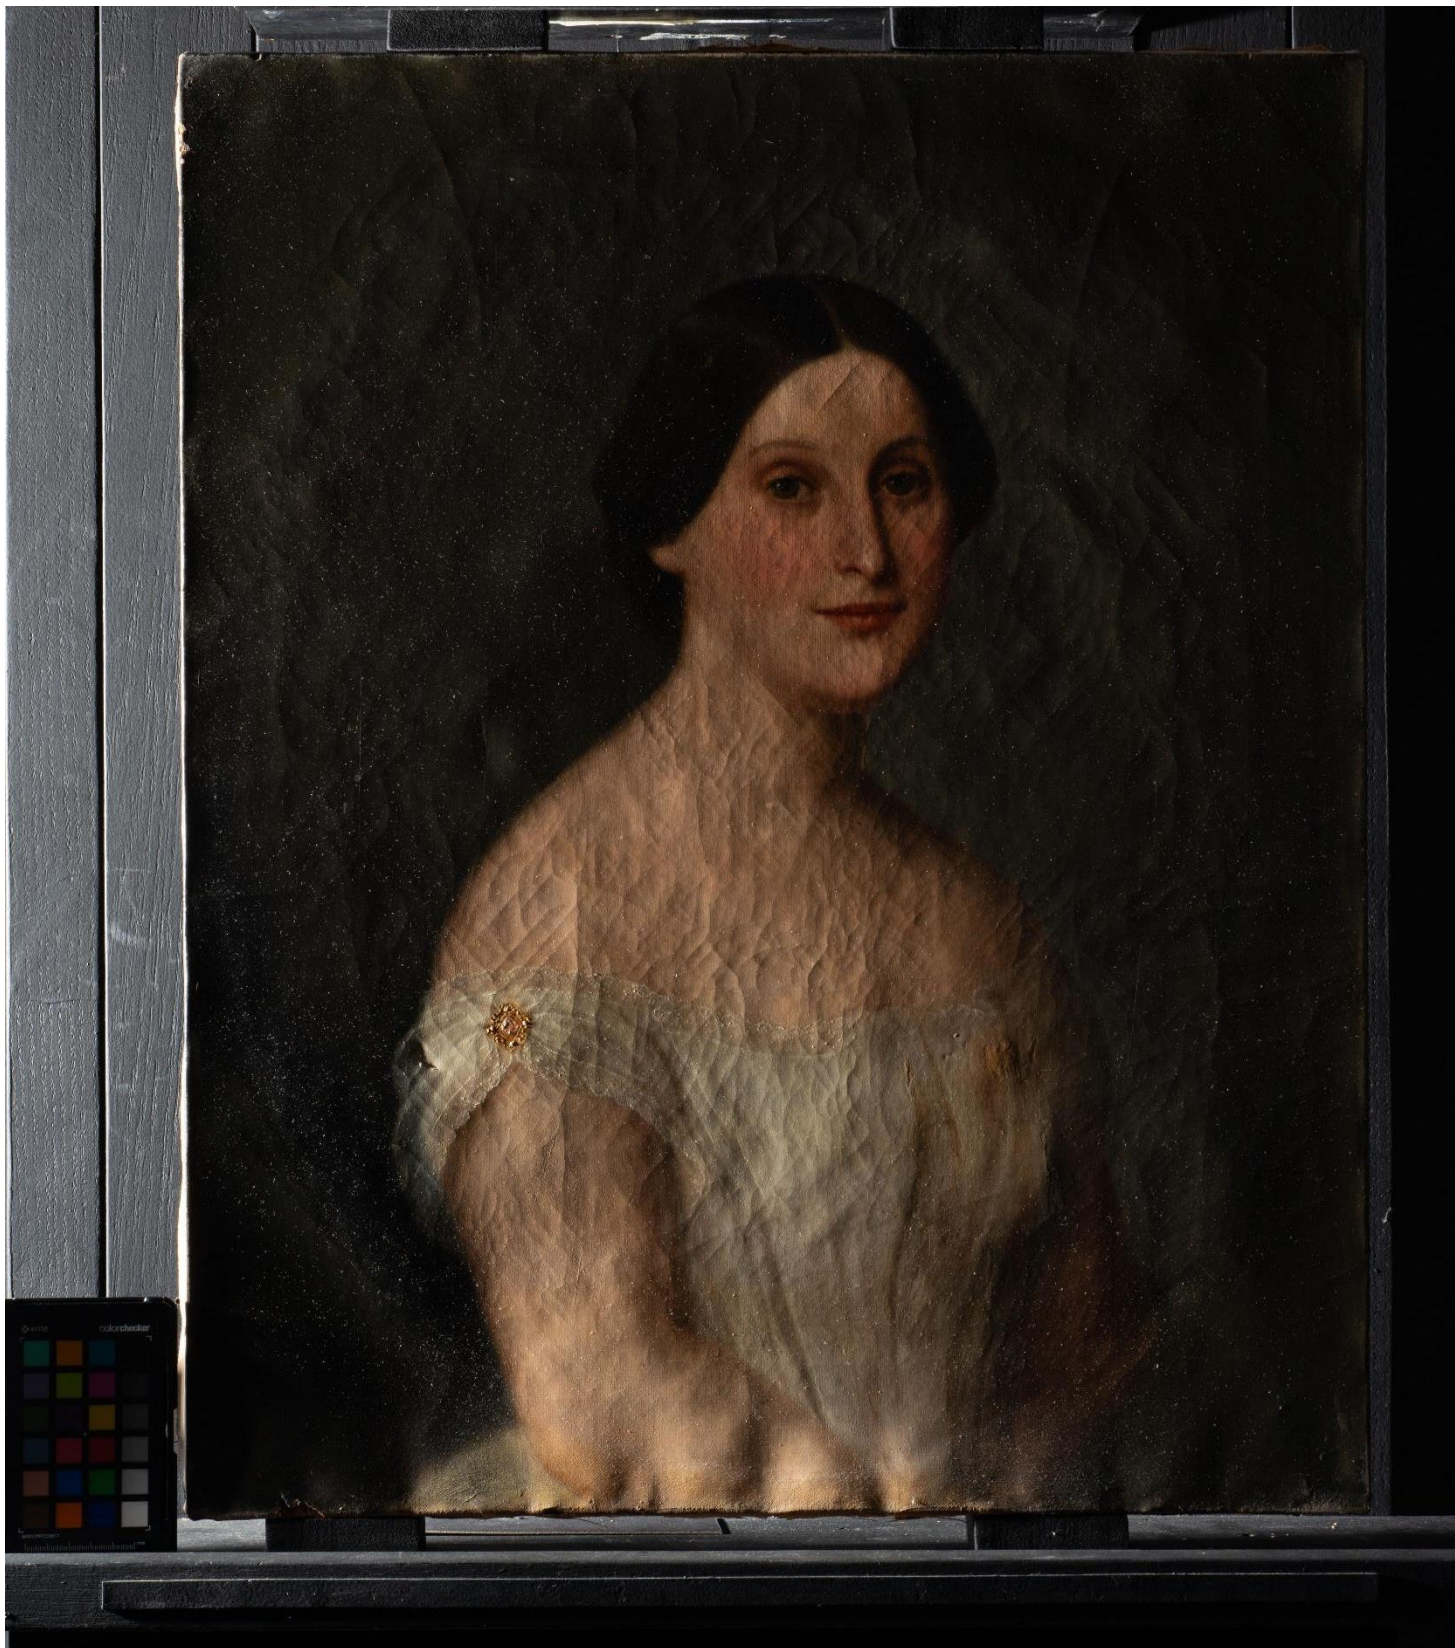
Figure 9. Raking light.

The canvas is in fair condition. It is darkened and brittle due to the natural degradation of the cellulosic fibers. There are some canvas bulges in the lower left corner and along the lower left edge, seen in the raking light photograph (fig. 9). These likely result from the detachment of the lower tacking margin from the center seven tacks, which causes it to move freely. The tacks have corrosion products present resulting in staining of the canvas and fall out. The lower tacking edge is also shorter than the side tacking edges.

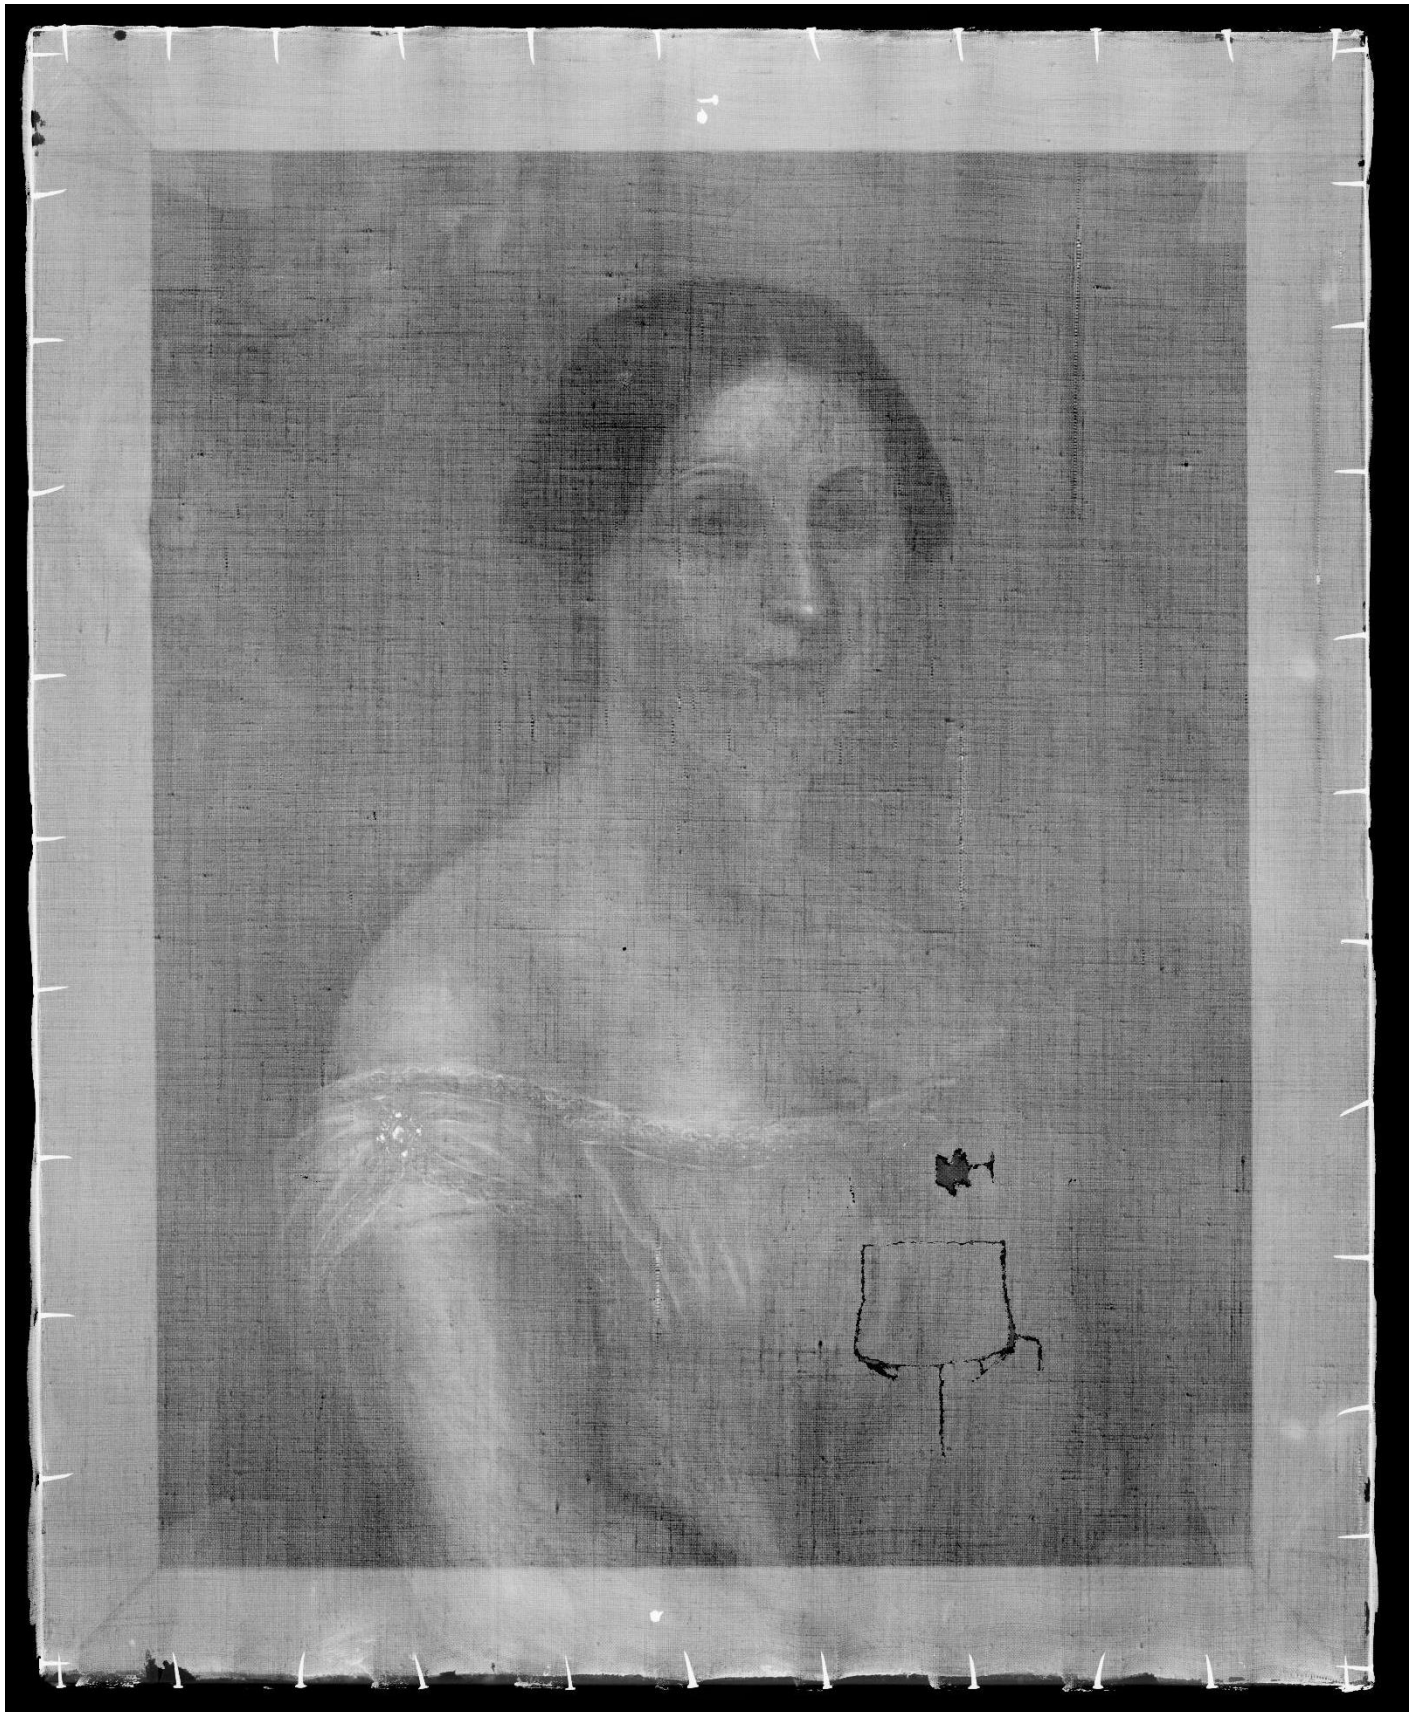
Figure 10. X-radiograph. Pantak-Seifert Eresco 65 MF2 with digital control. CRxVision Versatile Computed Radiography (CR) tabletop Scanner with IPS Phosphor Imaging Plates. Scans collected with GE Rhythm RT software and processed with GE Rhythm Review software. X-ray taken at 25kV, 5mA, 30sec.

The lower tacking edge has extra pinholes associated with the priming of the canvas on a temporary strainer. These holes indicate that the prepared canvas was narrow (approximately 27.75 inches) and long. This caused primary cusping. When the canvas was attached to this strainer with tacks, secondary cusping occurred, which is revealed by the alternating black and white vertical areas in the x-ray radiograph (fig. 10).

The priming layer is well adhered to both the support and paint layers and is in good, stable condition overall. The tears in the primary support described above are associated with some losses in the ground layer. Tears and losses in the canvas can be clearly seen in the x-radiograph (fig. 10) and will appear dark compared to lighter, more radiodense materials such as the lead white ground.

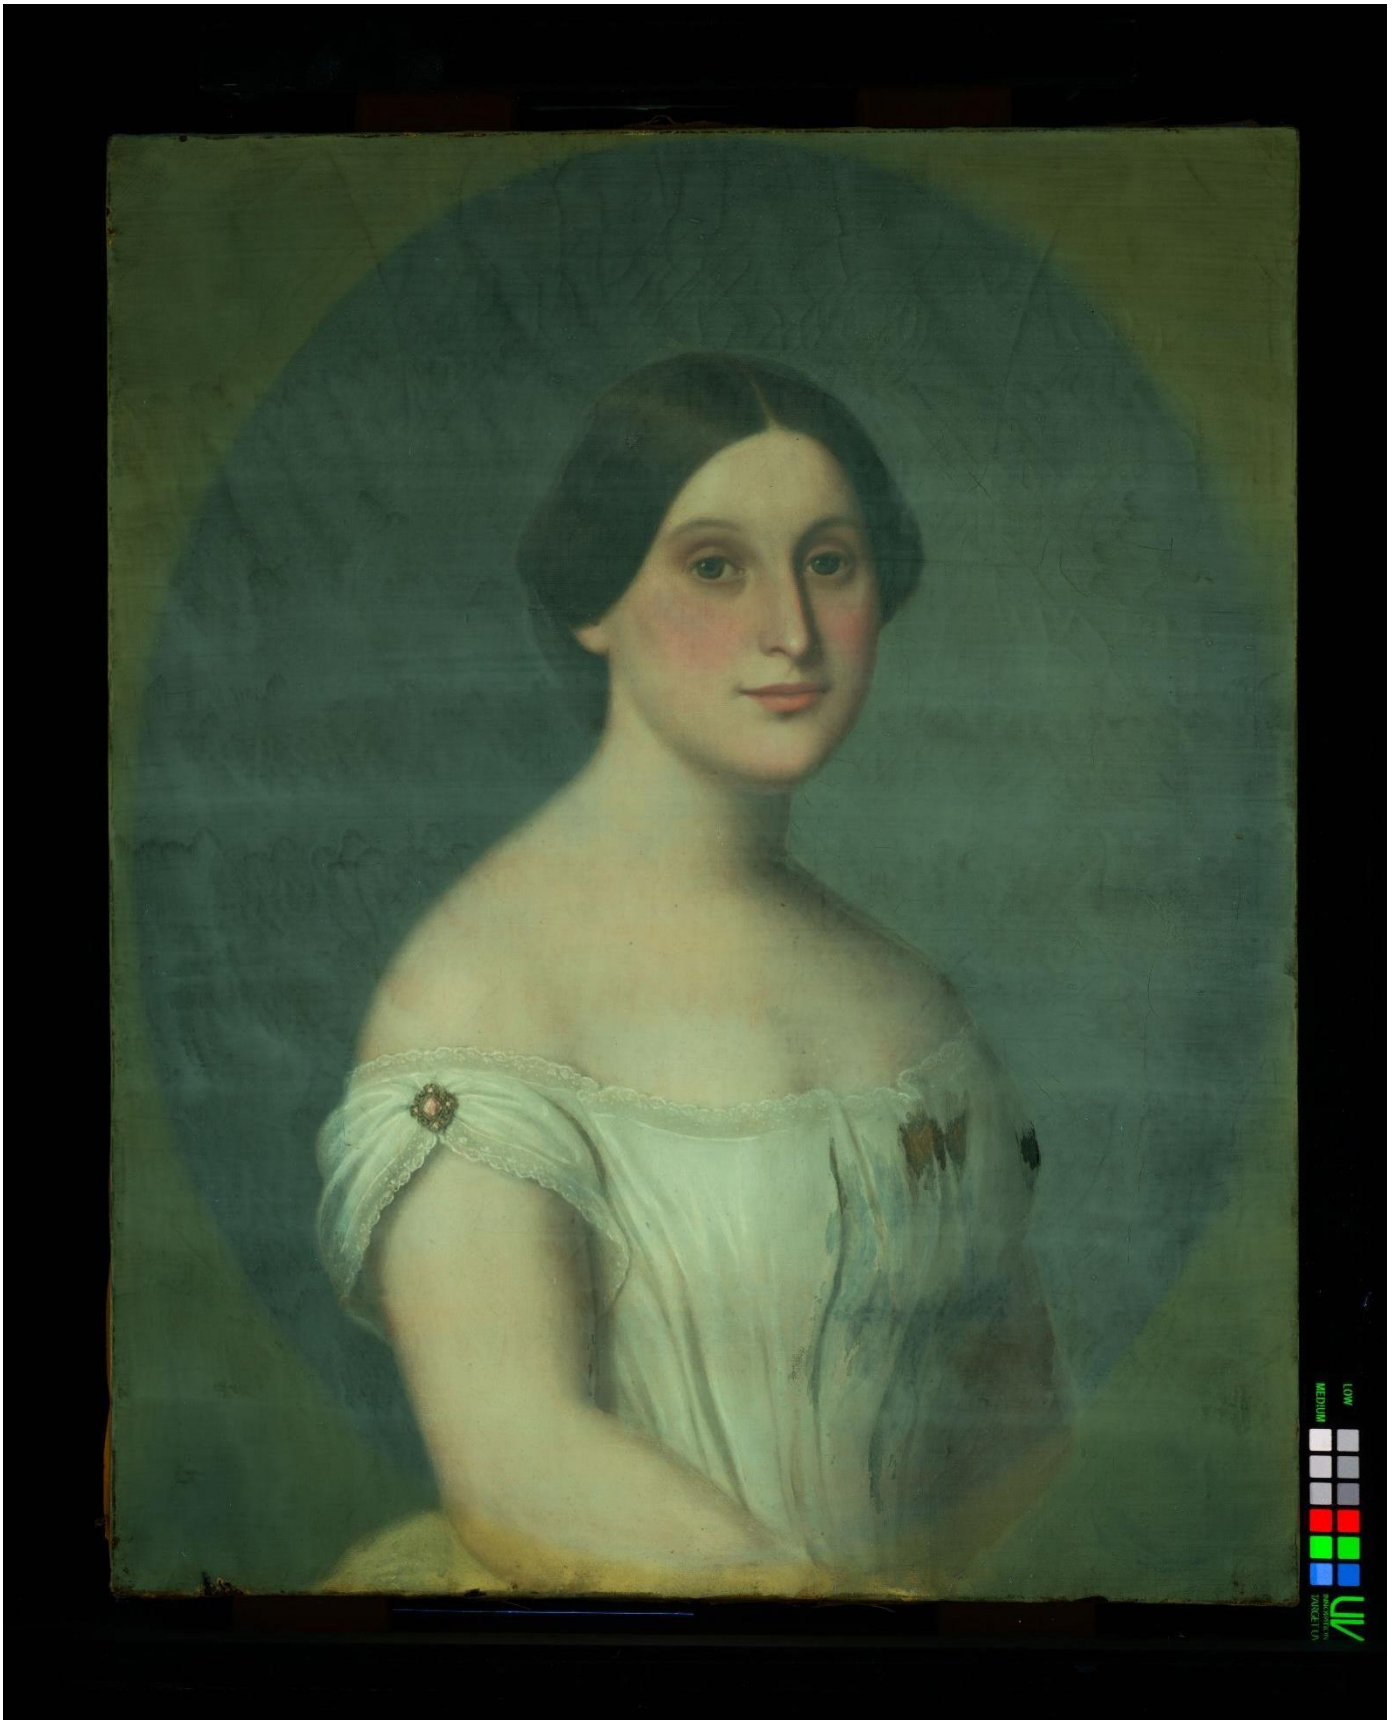
Figure 12. Ultraviolet-induced visible fluorescence. WildFire SableLED UV lights, model L15T8/BLB, 365 nm \pm 10 nm. Modified NIKON D800 camera, 60 mm lens. F/10, 6 sec, ISO 100.

The varnish has discolored. The corners of the painting that were covered by the frame fluoresce slightly differently than the rest of the painting. One possibility is that the frame protected the surface from pollutants and light which can cause degradation. UV light examination also reveals that someone had previously attempted to remove or reduce the natural resin varnish layer.

12. Perform solubility testing to determine the optimal solution that will allow the safe removal of the varnish and overpaint.
13. Apply an isolating layer of stable synthetic varnish with a brush.
