WUDPAC PAINTINGS BLOCK
EXAMINATION REPORT AND TREATMENT PROPOSAL

ACCESSION #	2024.0019A,B
ARTIST	Hans Heinrich "Henry" Bebie
TITLE	<i>Portrait of a Woman</i>
DATE	c. 1850-1860
MEDIUM	Oil on canvas
SIZE	H 68.1cm x W 55.1 cm (H 26.75 in x W 21.75 in)
EXAMINED BY	Elizabeth Glander
DATE	March 19, 2025
CONSULTANTS	Bianca Garcia, Associate Conservator of Paintings and Programs Manager at Balboa Art Conservation Center Mina Porell, Associate Paintings Conservator at Winterthur Museum, Garden and Library

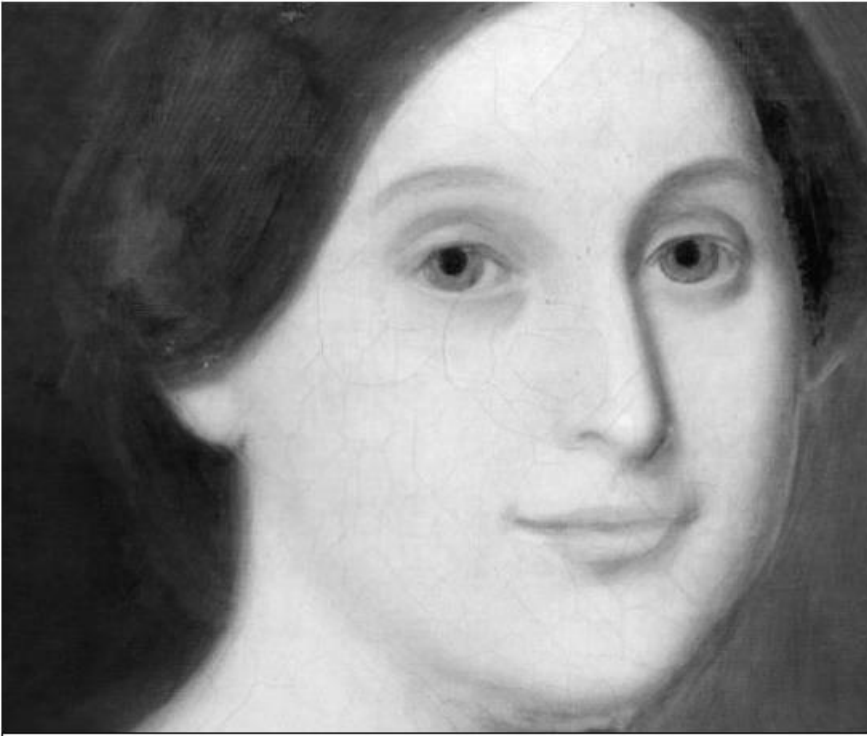
Infrared reflectography (IRR) imaging (fig. 11) reveals a preparatory drawing in the eyes, nose, and mouth, in the 900-1700 nm range. Thin lines, likely applied with a dry medium and a pointed tool, are visible. The eyelids were originally drawn covering more of the eye but then reworked to be more open (fig. 4)

Figure 4. Detail image of figure's head showing the preparatory drawing. Apollo Camera by Opus Instruments (900-1700 nm). Apollo 1.1.4.0 software. Tow Lowel Totalite Tungsten flood lights, at a 45-degree angle. 30 milliseconds integration time. No filter.

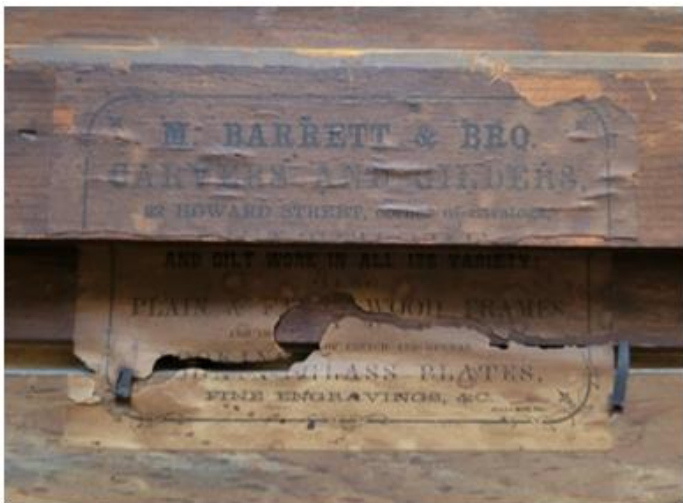
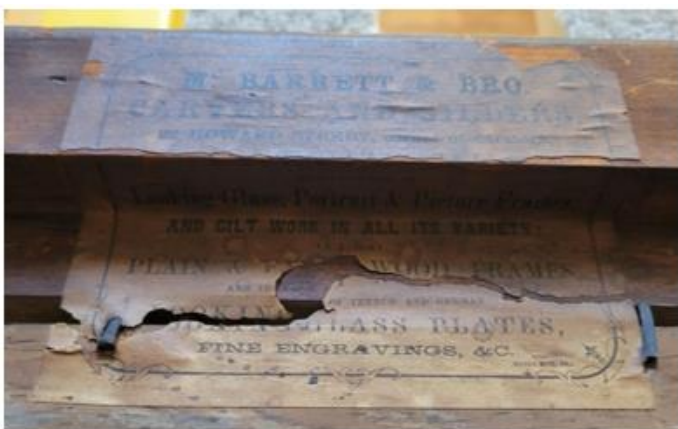
There is an old paper label, printed in black ink, that is adhered to the upper left corner (see "Inscriptions and Labels" above for more information) on the verso. Figures 5a,b show detailed photos of the label.

Figure 5a. Overall image of the label on the verso of the frame.

Figure 5b. Another angle of the label on the verso of the frame to capture more of the writing.

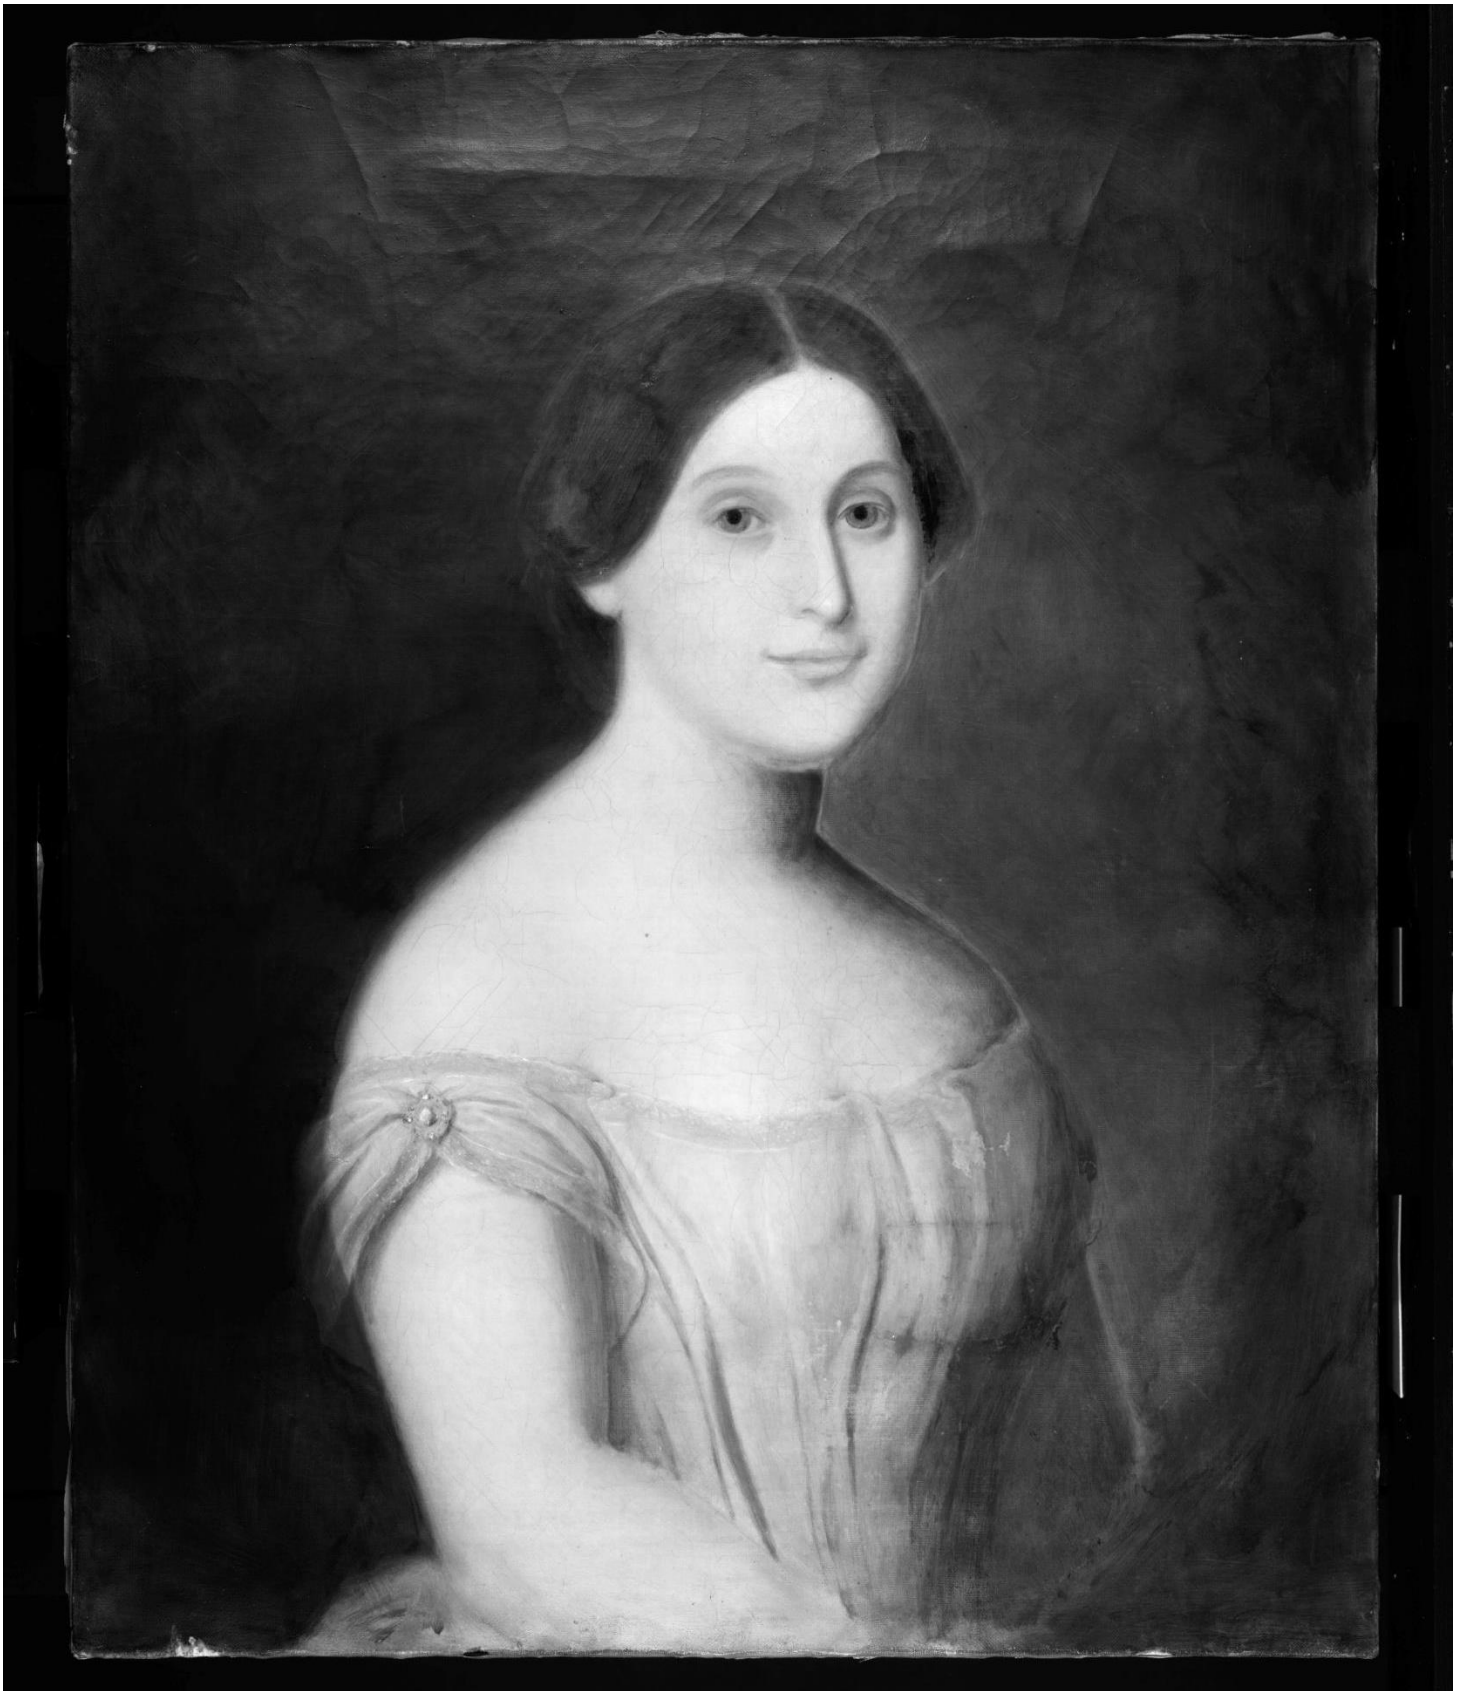
Figure 11. Infrared reflectography. Apollo Camera by Opus Instruments (900-1700 nm). Apollo 1.1.4.0 software. Two Lowel Tota-Lite Tungsten flood lights, at a 45-degree angle. 30 milliseconds integration time. No filter.
